**BOEING AIRPLANE COMPANY**  
**WICHITA, KANSAS**

DOCUMENT NO. WD-14018 DATE January 31, 1956

MODEL BC-47E CONTRACT NO. 5148

TITLE ANALYSIS OF WFT-709 FLIGHT TESTS OF NAVIGATOR'S  
COMPARTMENT DEFROSTING SYSTEM

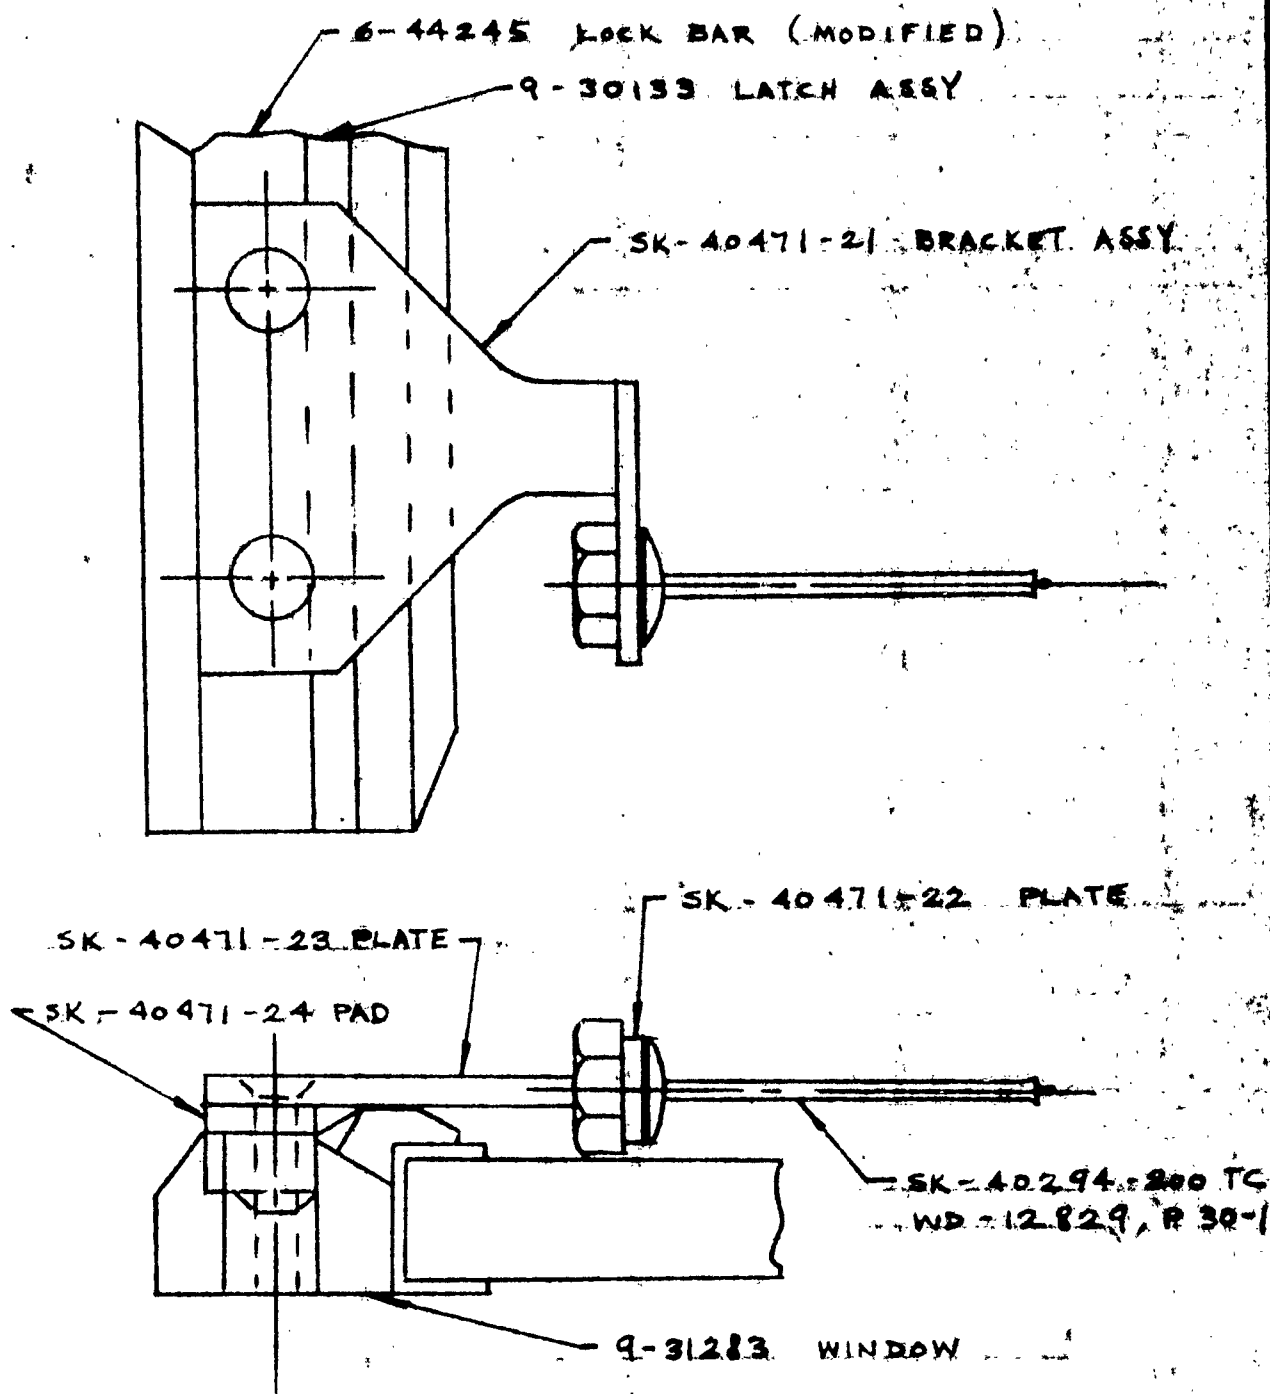
TC NO 73

WELL TEMPERATURE - VIEWFINDER WINDOW

CALC <i>SK 7-7-9</i> CHG <i>M. PECHT 6-58</i> APR APR	REVISED    	DATE    	FLIGHT TEST INSTRUMENTATION - WELL TEMPERATURE, VIEWFINDER WINDOW  BOEING AIRPLANE COMPANY WICHITA DIVISION      WICHITA 1, KANSAS	FIGURE 50  WD-475 WD-14018 PAGE 101
CONTRACT NO.

The location of the temperature instrumentation on the window surfaces is shown in Figures 46, 49, 52 and 53. The well temperature thermocouple locations are shown in Figures 47, 48, 50 and 51. Duct line and miscellaneous pressure and temperature instrumentation locations are shown in Figures 41 to 45 inclusive. Additional details covering the remaining flight test instrumentation are included in Insert 1.

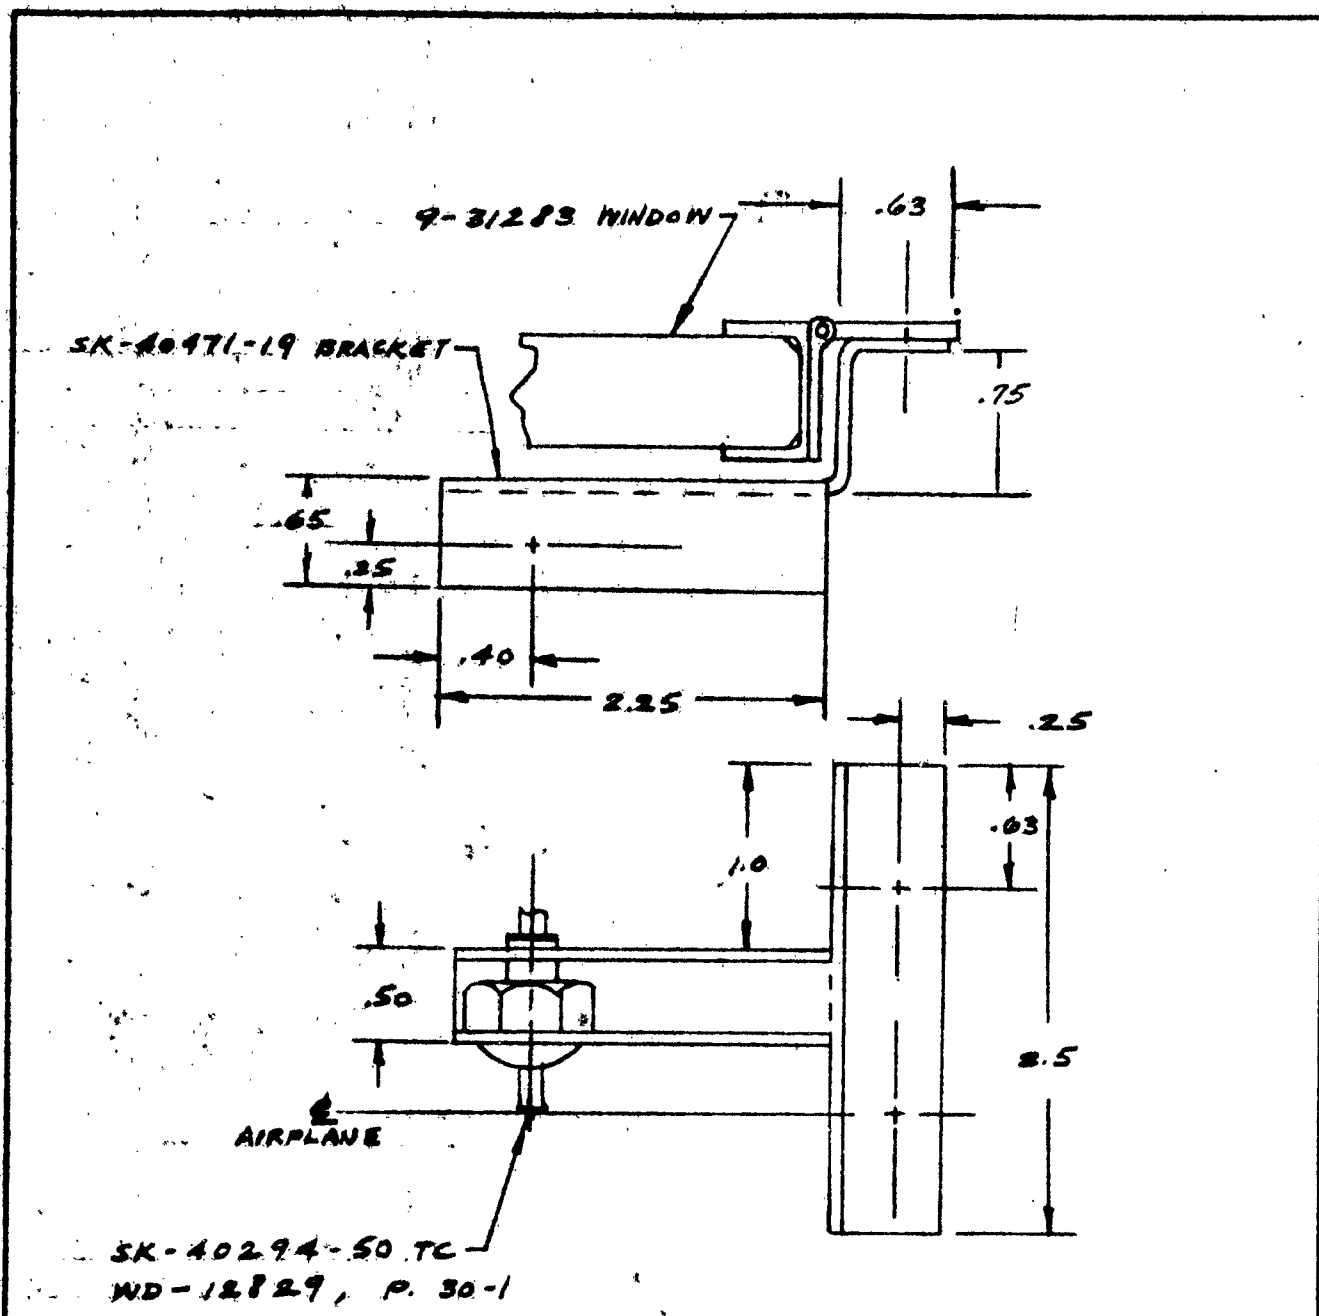
TC NO. 74

WELL TEMPERATURE - VIEWFINDER  
WINDOW

Calc	7-7-4	REVISED	DATE	FLIGHT TEST INSTRUMENTATION - WELL TEMPERATURE, VIEWFINDER WINDOW	FIGURE 51
CHECK	M. PECHT	A-56			RD-47E
APR					WD-14018
APR					PAGE 102
CONTRACT NO.				BOEING AIRPLANE COMPANY WICHITA DIVISION WICHITA, KANSAS

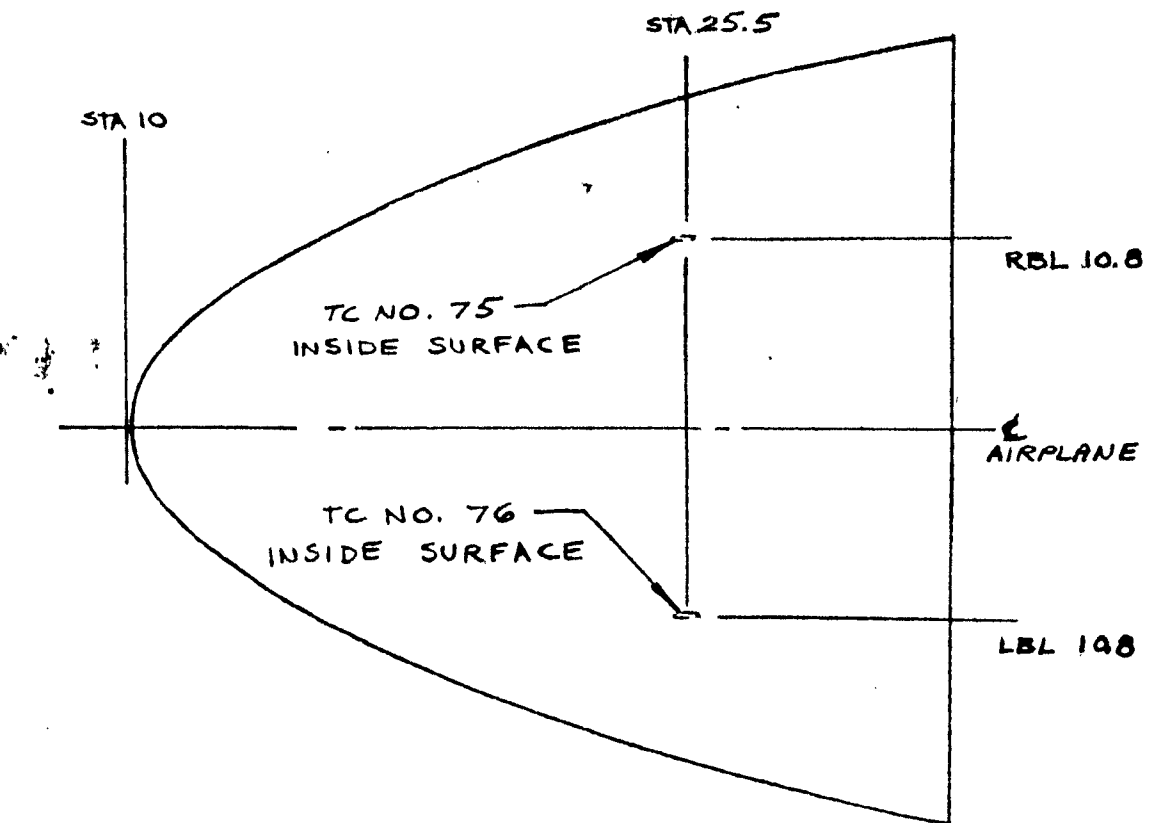
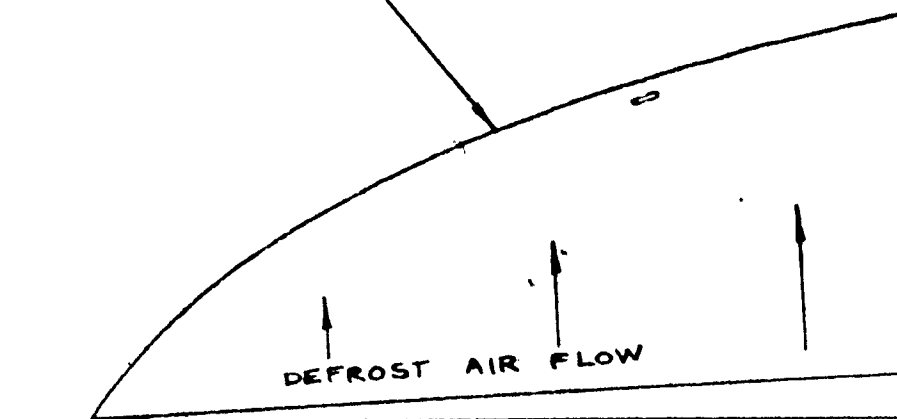
WL126.65

TC'S NO 75 + 76  
INSIDE SURFACE TEMPERATURE,  
NOSE COVER WINDOW

CALC	MC	7-7-4	REVISED	DATE	FLIGHT TEST INSTRUMENTATION - INSIDE SURFACE TEMPERATURE, NOSE COVER WINDOW	FIGURE 52
CHECK	M. PECHT	6-55				RD-47E
APR						WD-14018
APR						PAGE 103
CONTRACT NO.					BOEING AIRPLANE COMPANY WICHITA DIVISION WICHITA 1, KANSAS

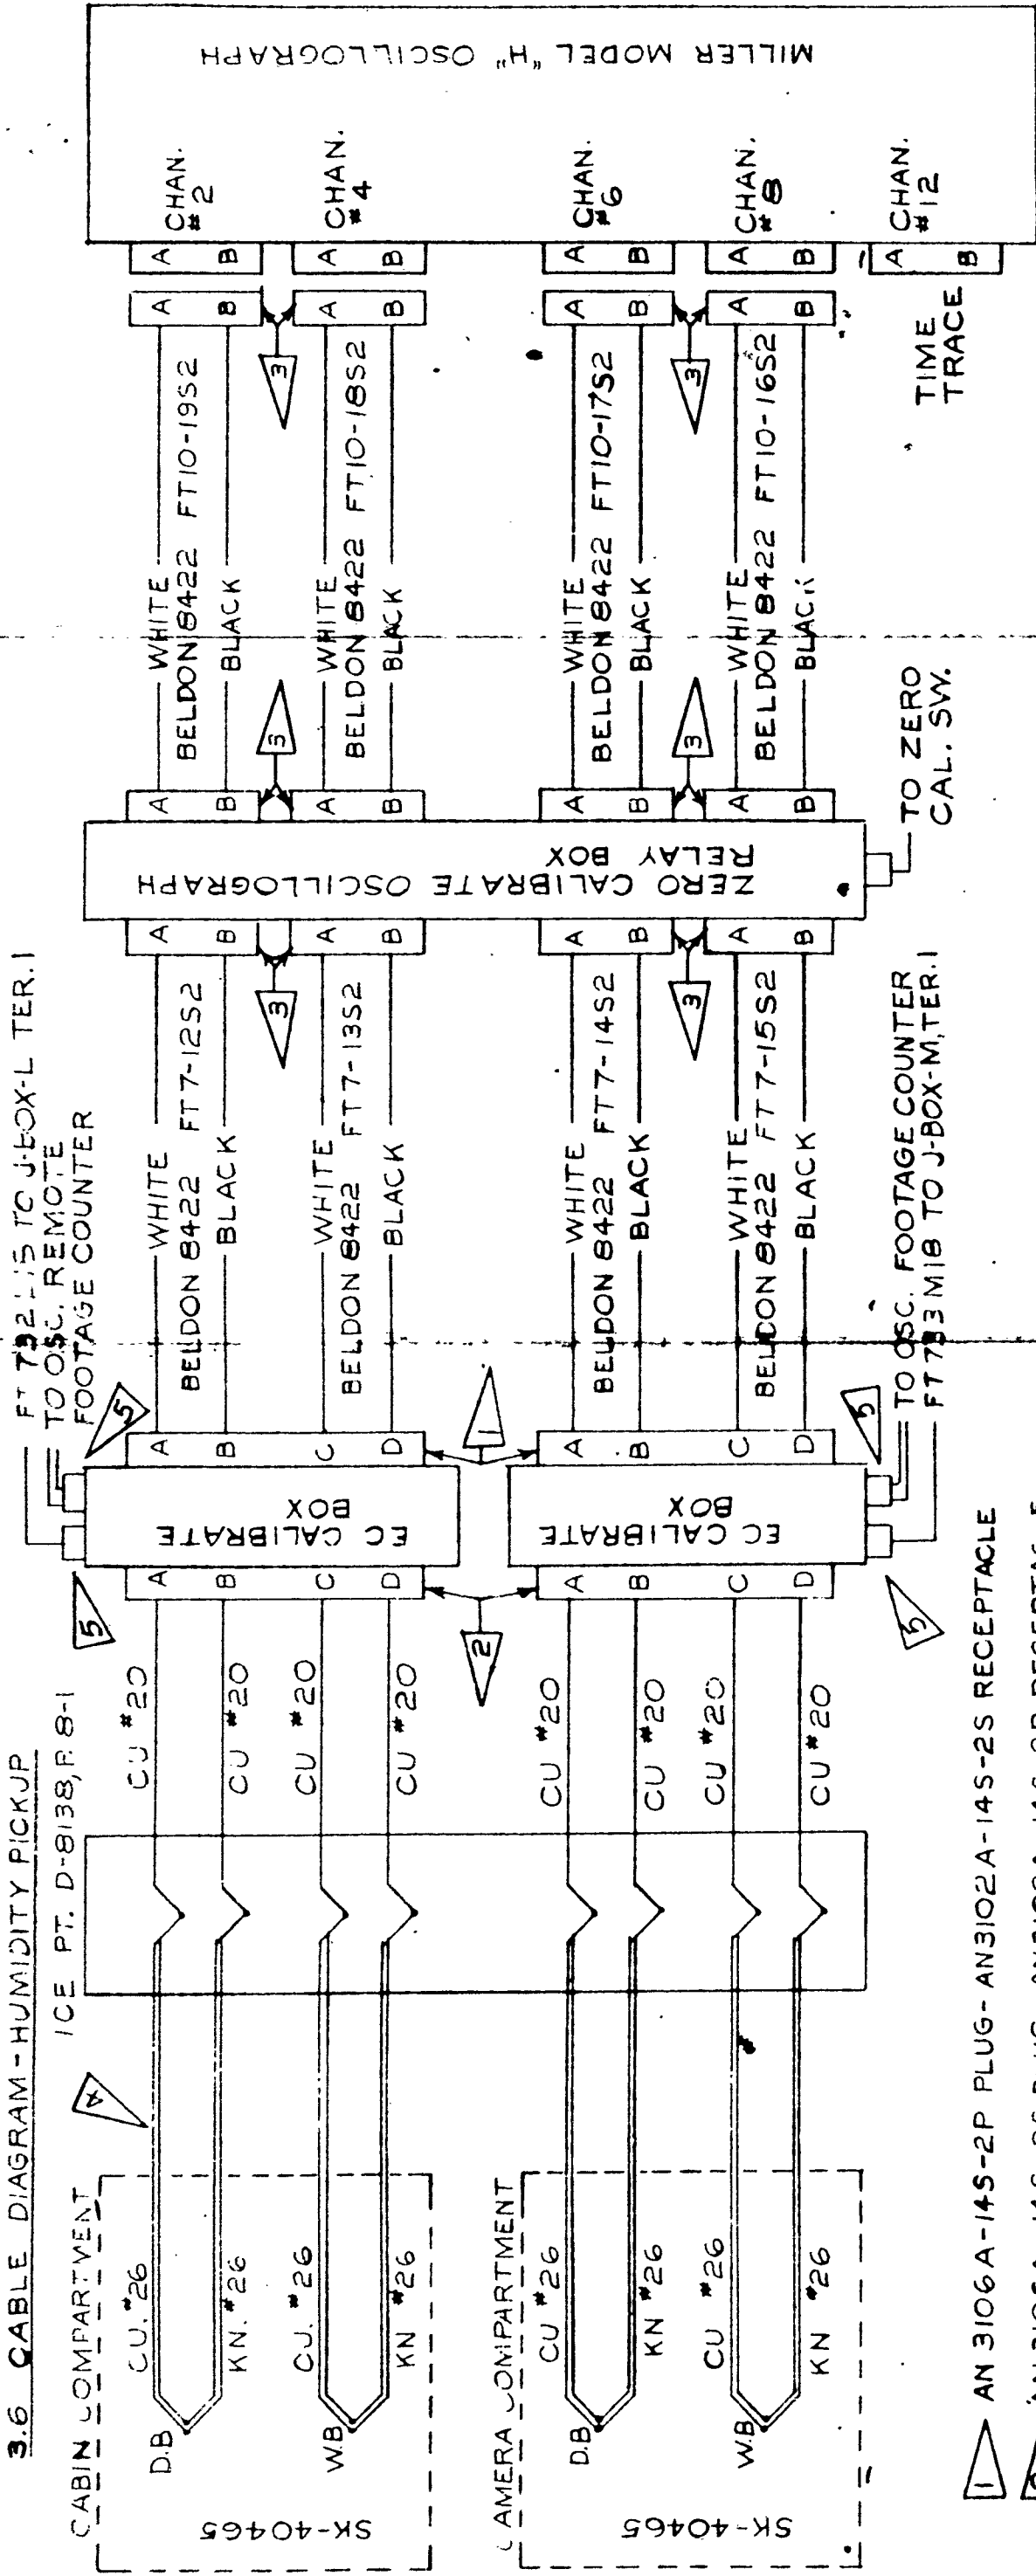
### 3.6 CABLE DIAGRAM - HUMIDITY PICKUP

- 1 AN 3106A-14S-2P PLUG - AN3102A-14S-2S RECEPTACLE
- 2 AN 3106A-14S-2S PLUG - AN3102A-14S-2P RECEPTACLE
- 3 AN 3106A-10SL-4S PLUG - AN3102A-10SL-4P RECEPTACLE
- 4 THERMOELECTRIC CU-KN DUPLEX THERMOCOUPLE WIRE IN PARALLEL TO ICE POINT
- NOTE: FE-KN USED UP TO TEST 8-1
- NOTE: FOR WIRING DIAGRAM OF EC CALIBRATE BOX SEE WD12829, P.162
- 5 AN 3106-12S-3S PLUG - AN3102A-12S-3P RECEPTACLE

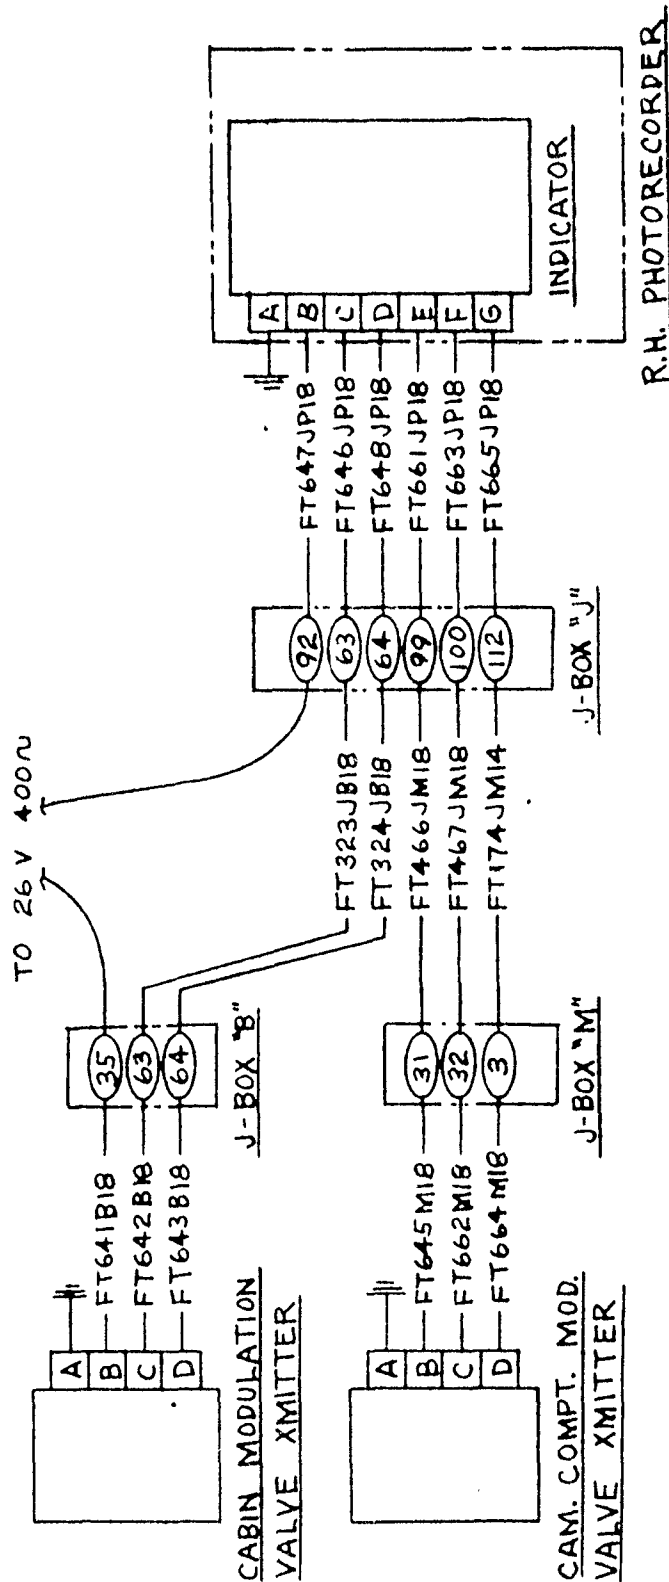
WIRING DIAGRAM - MODULATION VALVE POSITION

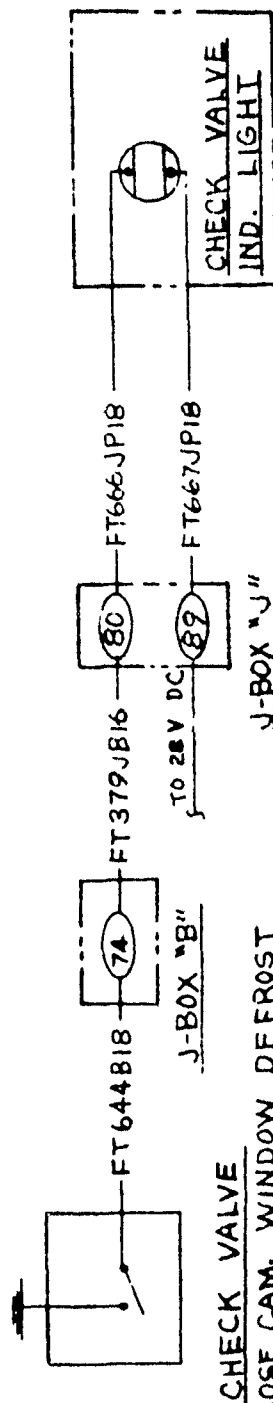
WIRING DIAGRAM - CHECK VALVE POSITION

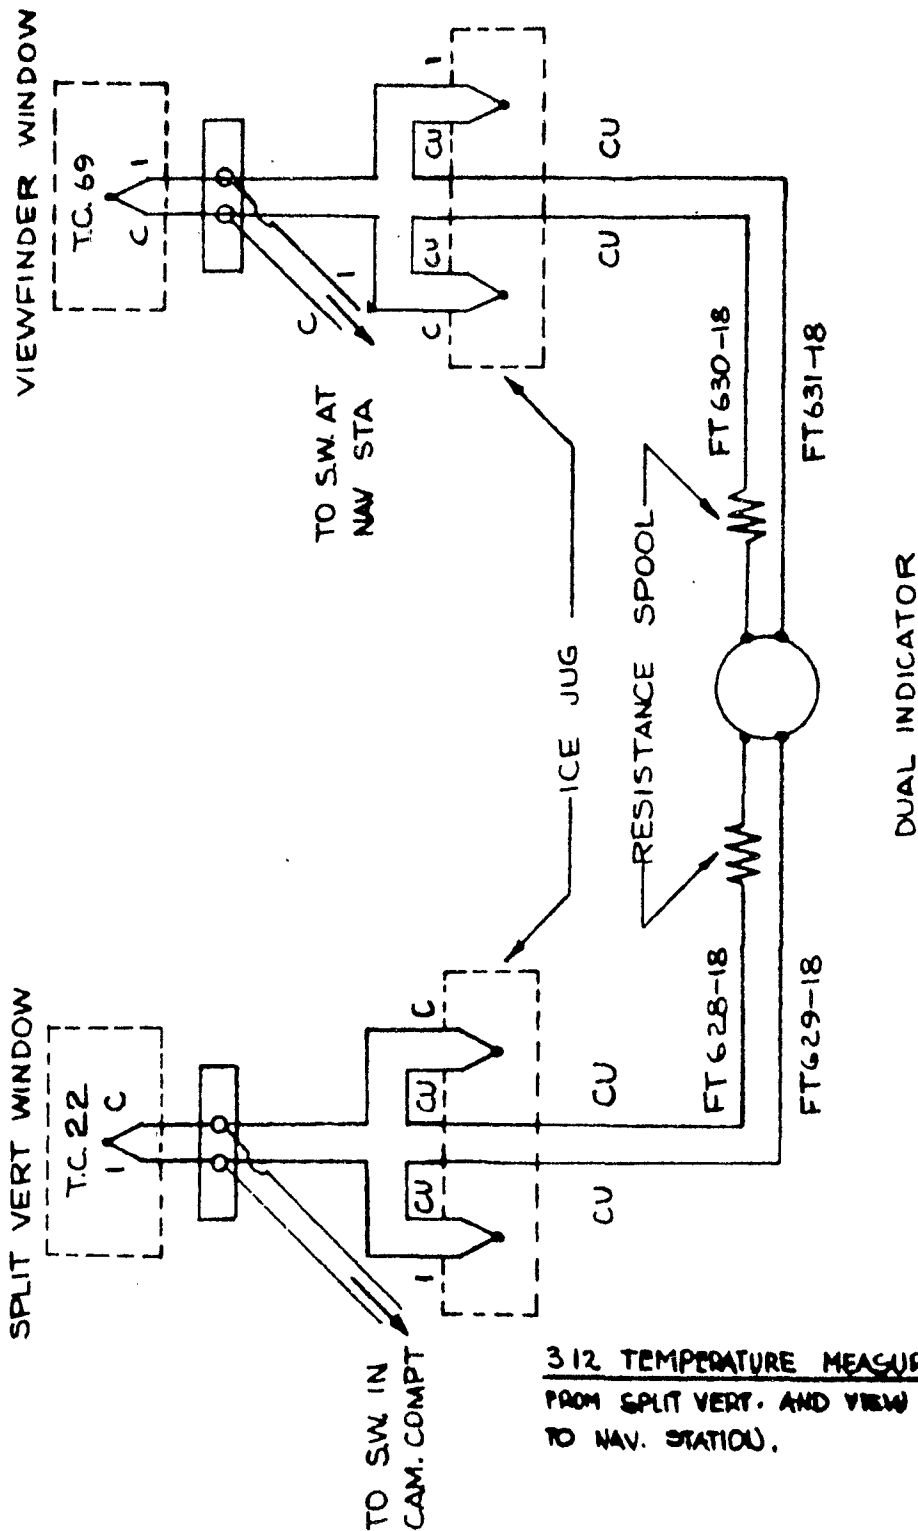
312 TEMPERATURE MEASUREMENTS AT NAV. STA  
FROM SPLIT VERT. AND VIEW FND. WINDOWS  
TO NAV. STATION.

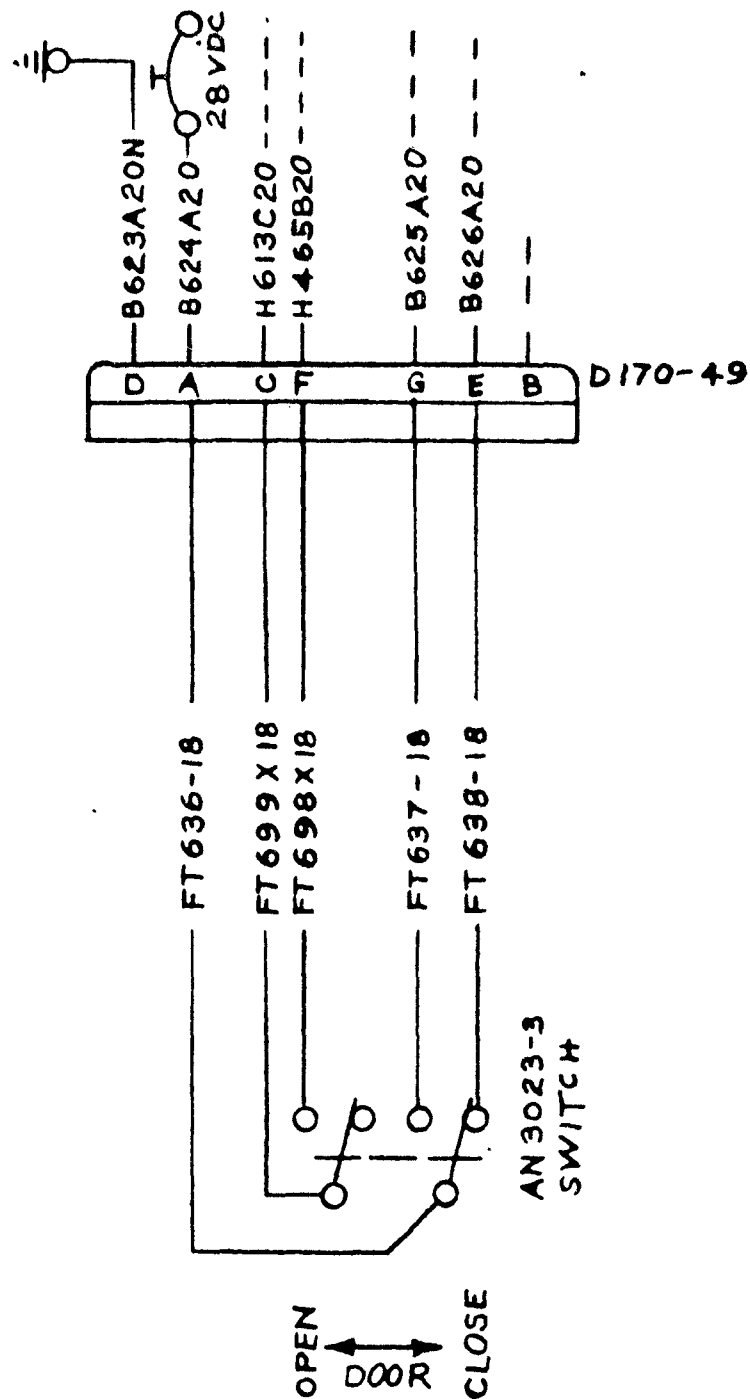
### 3.13 VIEWFINDER DOOR OPERATION (VIEWFINDER REMOVED)

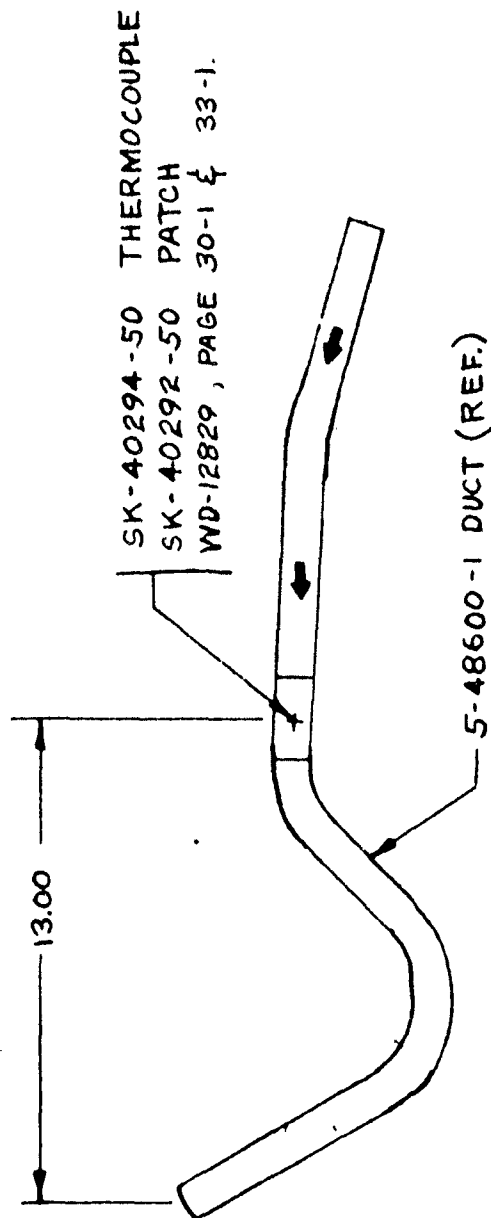
T-C NO. 53  
NOSE CAMERA WINDOW INSIDE SUPPLY DUCT

1.2.53 T-C Nose Camera Window Supply Duct - Inside Defrost

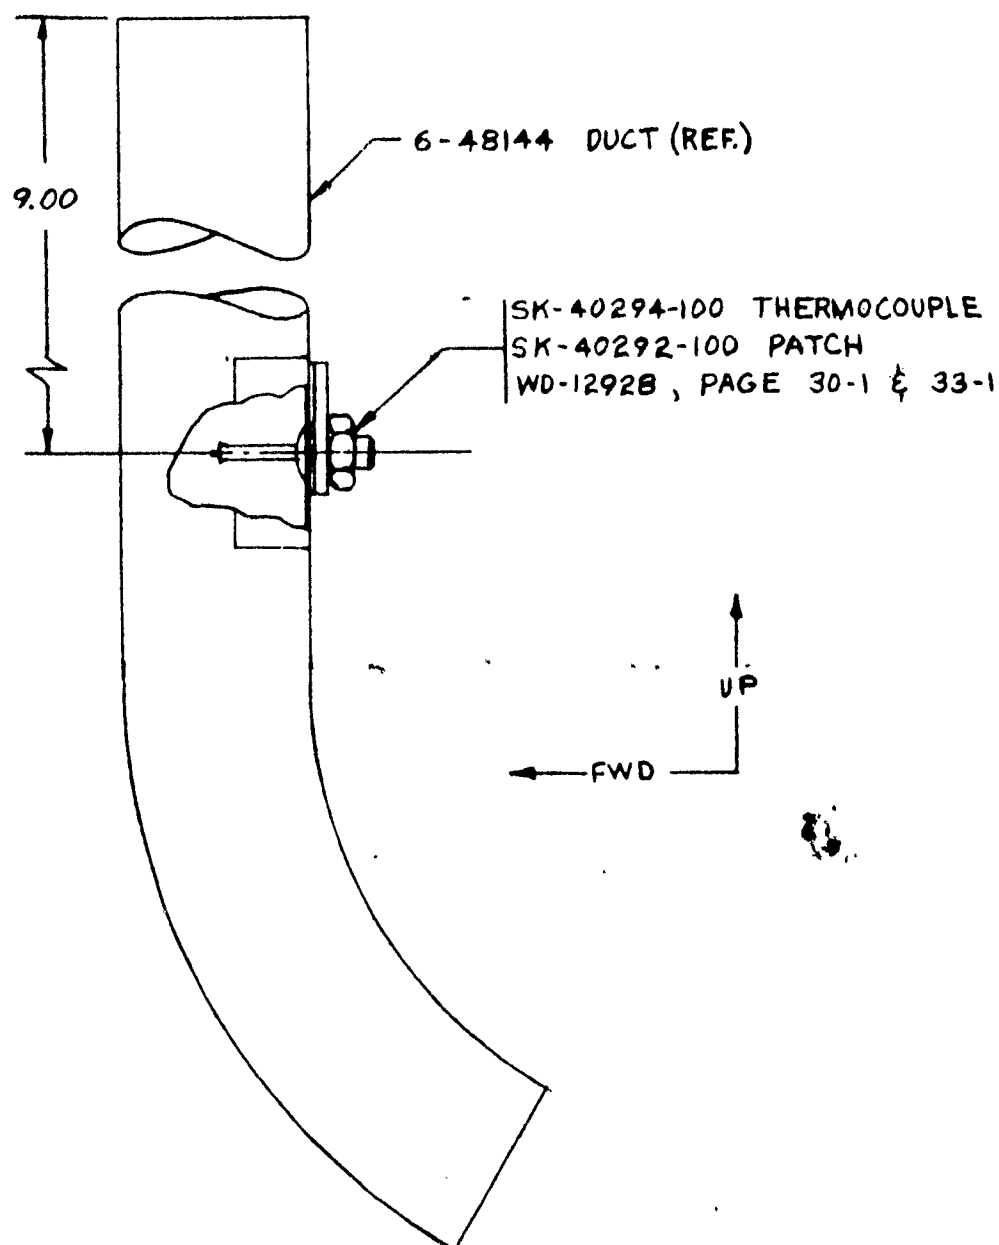
T-C NO. 54  
TEMPERATURE - CAMERA VENTILATION

1.2.54 T-C Camera Ventilation Supply Duct

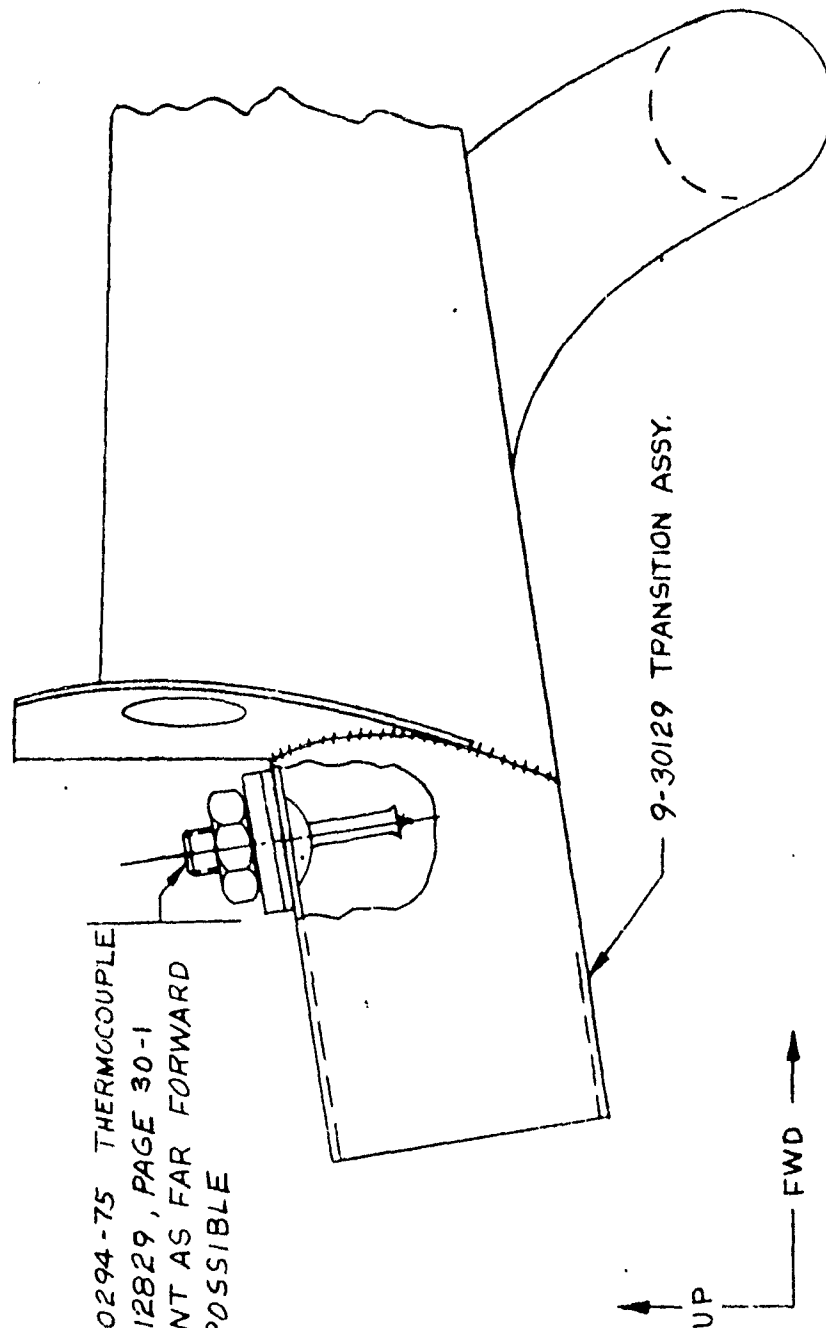
T-C NO. 55  
TEMPERATURE OF MIXED AIR NEAR SENSING POINT - NOSE CAMERA  
WINDOW OUTSIDE SUPPLY DUCT

SK-40294-75 THERMOCOUPLE  
WD-12829, PAGE 30-1  
MOUNT AS FAR FORWARD  
AS POSSIBLE

1.2.55 T-C Mixed Air Near Sensing Point

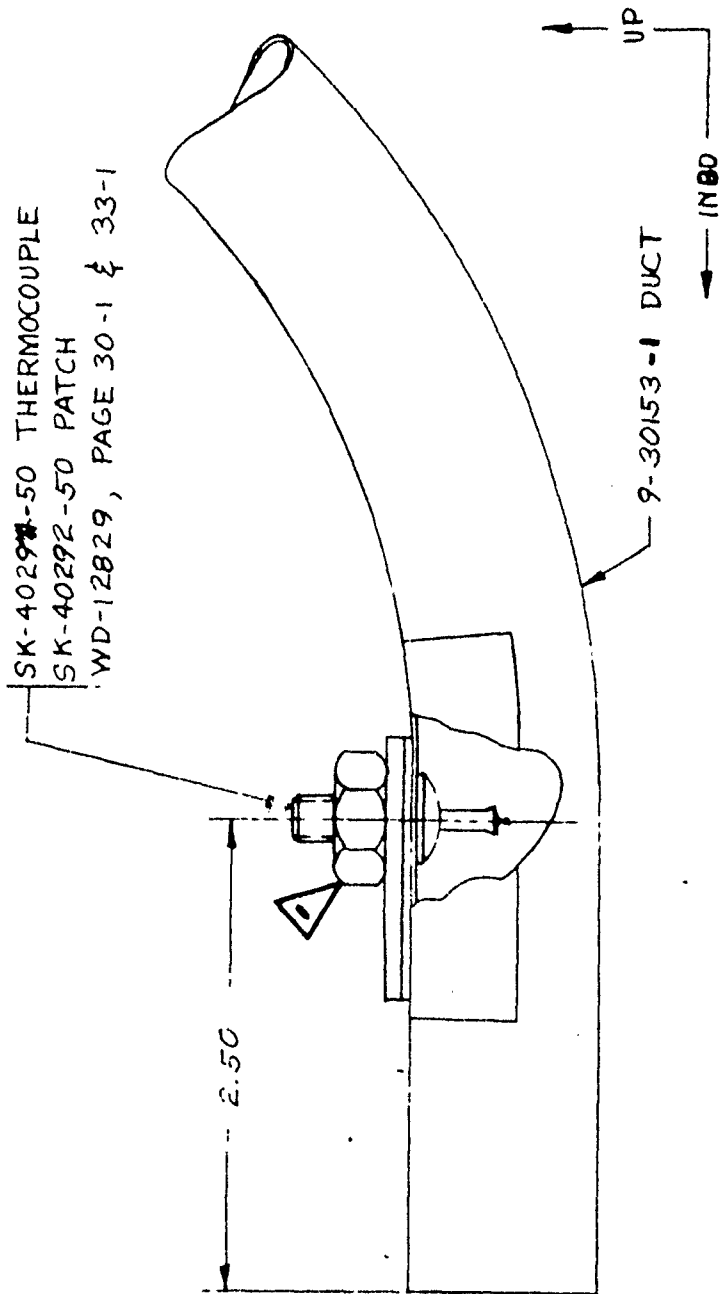
TEMPERATURE UPSTREAM OF CHECK VALVE - VIEWFINDER OUTSIDE SUPPLY DUCT

1.2.56 T-C Viewfinder Supply Duct - Outside Defrost

△ INSTALL T-C PICKUP 90° TO LOCATION SHOWN.

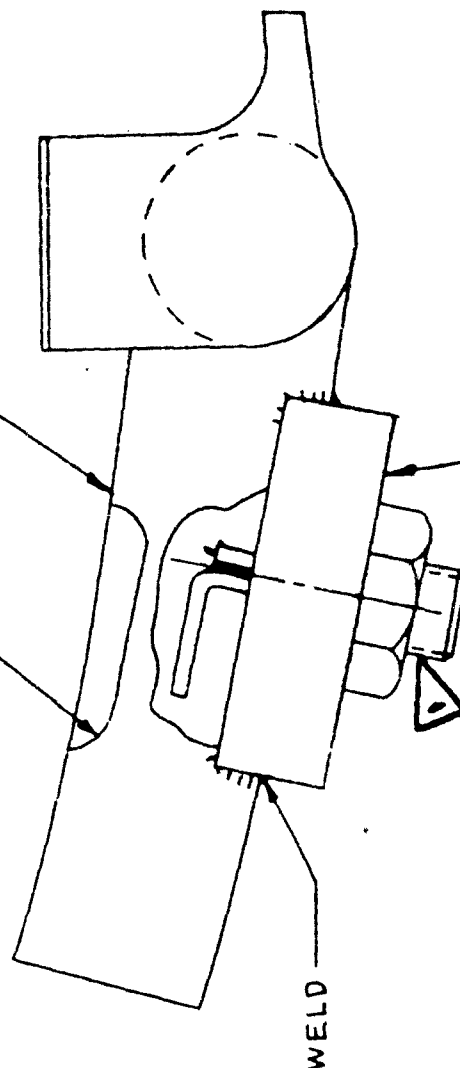
- 1.1.22 Static Pressure, Viewfinder Supply Duct - Outside Defrost
- 1.2.57 T-C, Viewfinder Supply Duct - Outside Defrost

SK-40464-50 FLOWMETER,  
WD-12829, PAGE 149-1  
OMIT -5 PITOT TUBE

INSTALL PLUMP ASG. 90° TO LOCATION SHOWN.

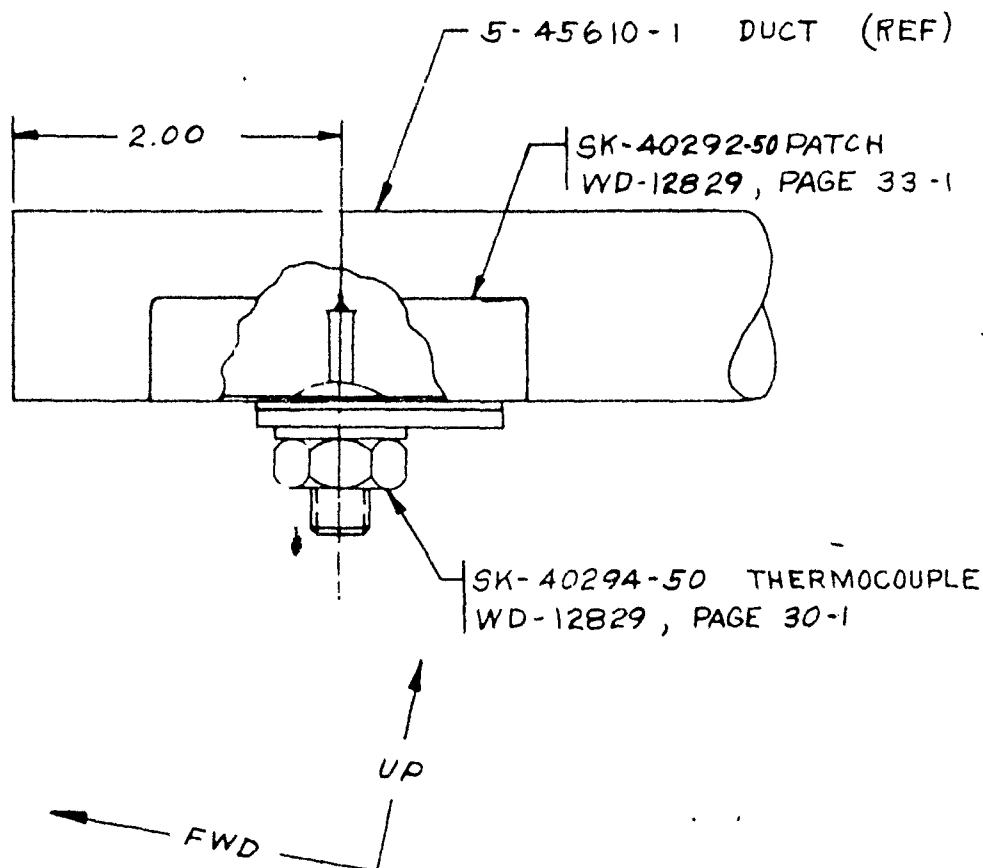
T-C NO. 58

TEMPERATURE UPSTREAM OF CHECK VALVE - NOSE  
CAMERA WINDOW OUTSIDE SUPPLY DUCT.

1.2.58 T-C, Nose Camera Window Supply Duct - Outside Defrost

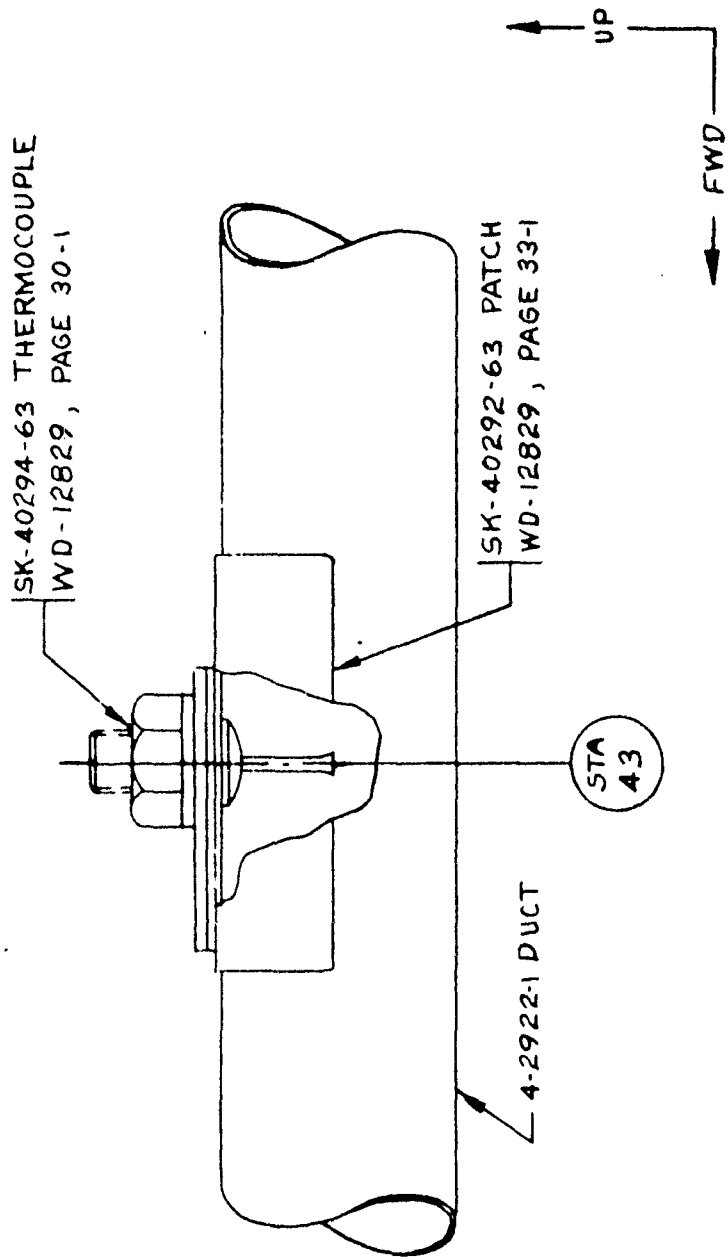
T-C NO. 60  
TEMPERATURE NEAR OUTLET - NOSE CANOPY SUPPLY DUCT

1.2.60 T-C, Nose Cover Supply Duct Near Outlet

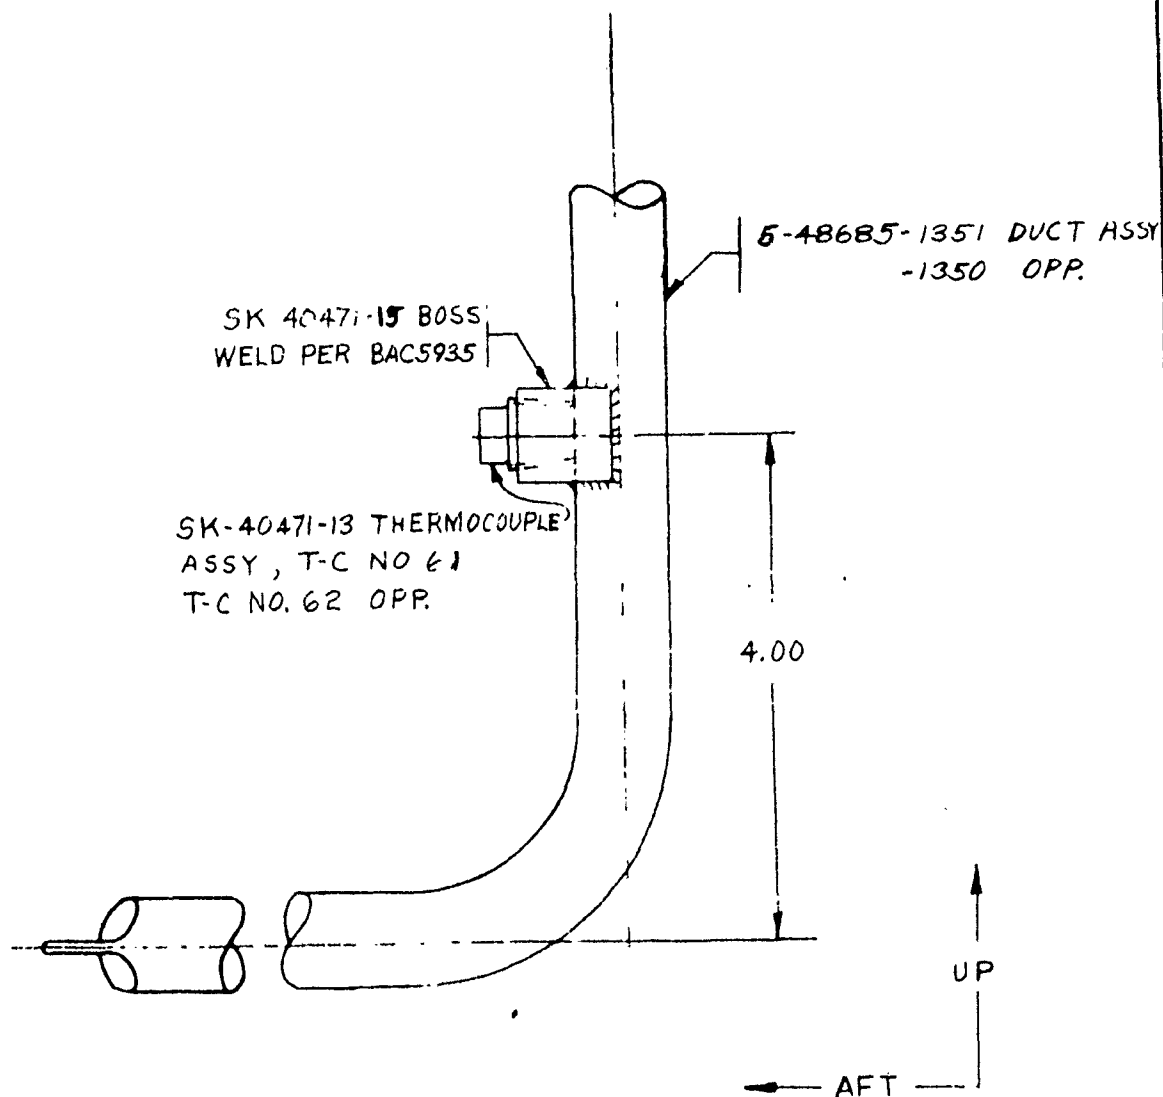
T-C NO. 61, T-C NO. 62  
 TEMPERATURE - NAVIGATOR'S WINDOW SUPPLY DUCT  
 L.H. INSTALLATION SHOWN - R.H. OPPOSITE

1.2.62 T-H, L.H. Scan Window Supply Duct  
 1.2.61 T-H, R.H. Scan Window Supply Duct

FINISH: ZINC CHROMATE PRIMER ON -15

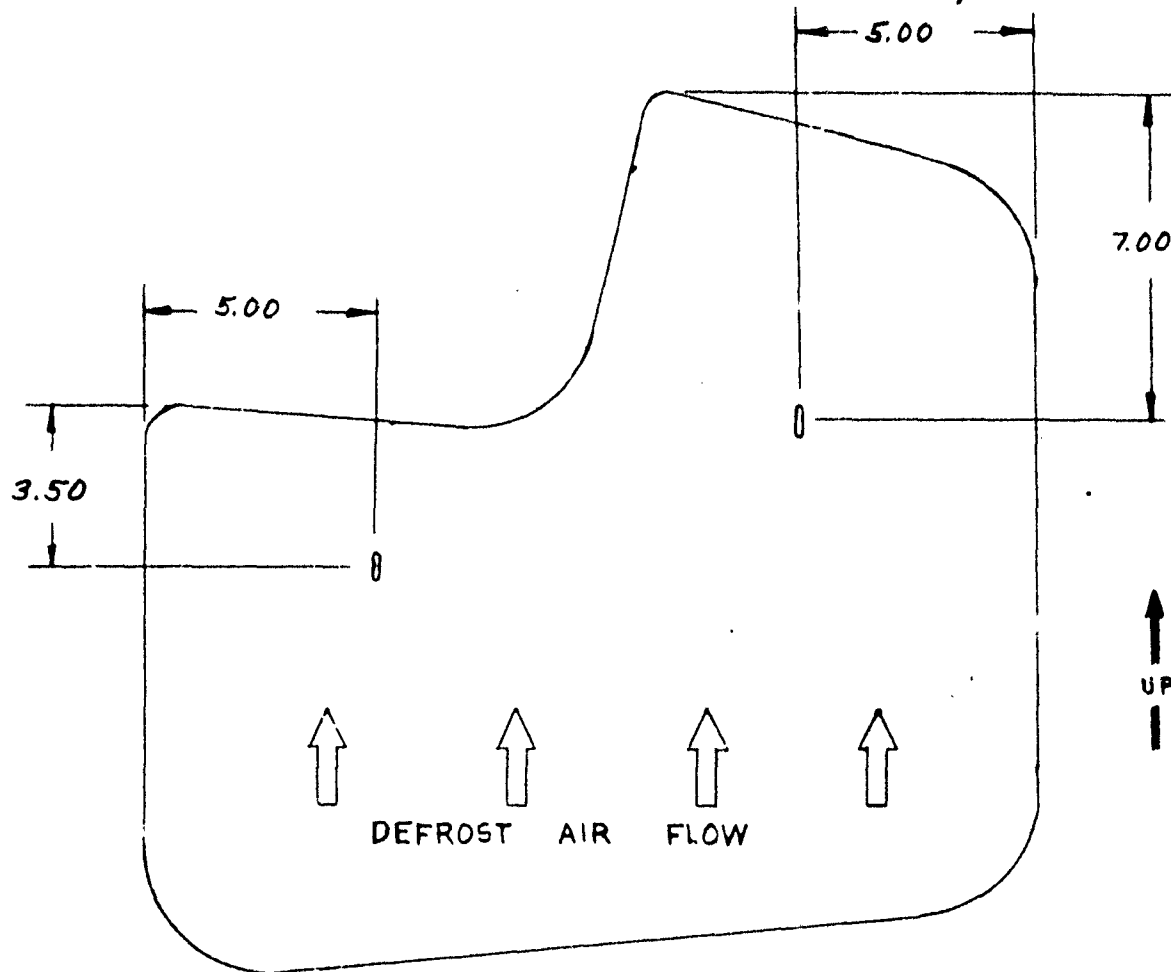
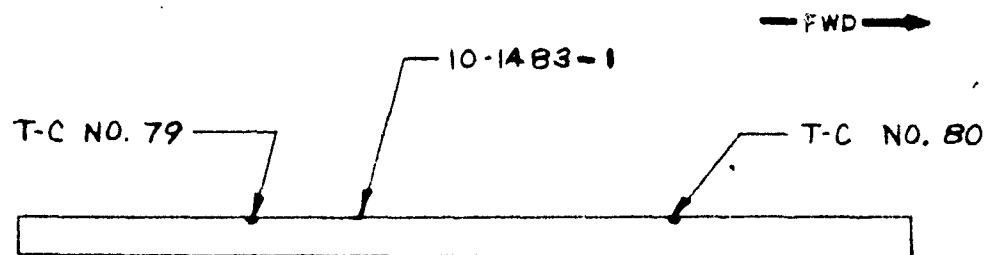
T-C NO. 79 , T-C NO. 80  
 INSIDE SURFACE TEMPERATURE , LEFT HAND SCAN WINDOW  
 (FOR T-C INSTALLATION DETAILS SEE PAGE 45.5 )

1.2.80 T-C, Left Hand Scan Window Inside Surface  
 1.2.79 T-C, Left Hand Scan Window Inside Surface

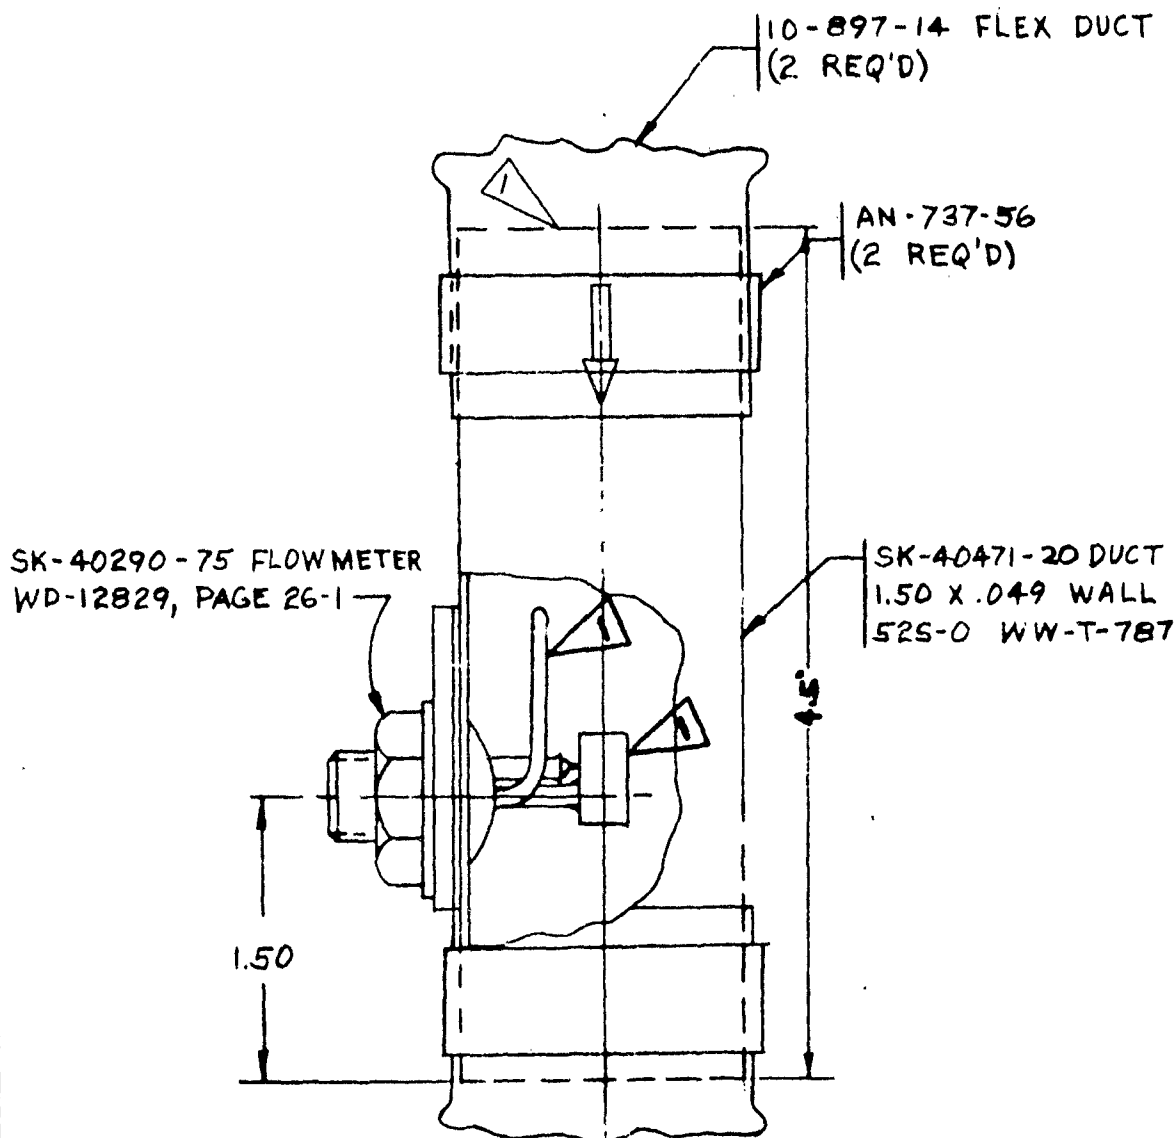
THIS INSTALLATION TO REPLACE 10-893-31 FLEX DUCT

1 CUT OFF THIS END OF -20 DUCT TO FIT ON INSTALLATION  
SEAL PER MAC 5000 TYPE XIV

- 1 1.1.24 Total Pressure, Mixed Air Flow to Outside Defrost  
1 1.1.25 Static Pressure, Mixed Air Flow to Outside Defrost  
1.2.81 T-C Mixed Air Duct to Outside Defrost

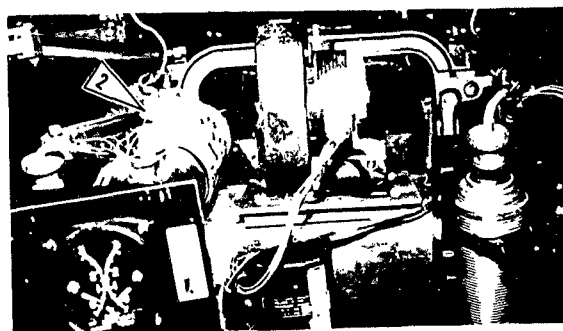
FTW 5533

10-1029-501 BLOWER FOR HUMIDITY MEASUREMENT
